Manhole Inspection Summary

Manhole # S35U__038MH

Insp Date: **3/20/08 2:48 PM**

Location Address: **1400 marshall**

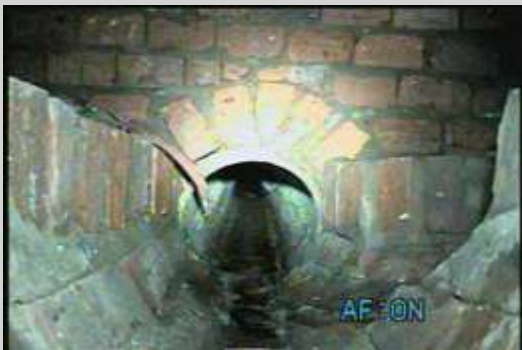
12 O'Clock Outflow

8 in. Circular Gravity Sewer
Pipe Out @ 12 O'Clock

Pipe Material: **Clay** ☐ Pipe Lined

Invert Depth: **8.00** (ft.) Flow Characteristics: **Slow**

Infiltration: **None** Pipe Seal Cond: **Unknown**

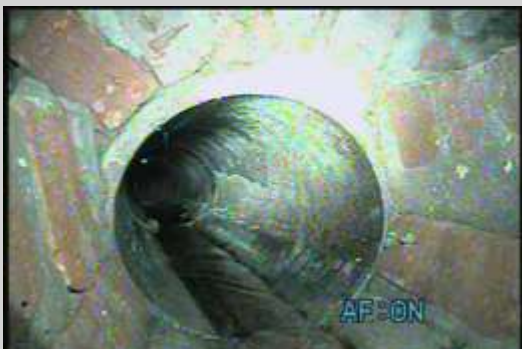
3 O'Clock Inflow

8 in. Circular Gravity Sewer
Pipe In @ 3 O'Clock

Pipe Material: **Clay** ☐ Pipe Lined

Invert Depth: **7.50** (ft.) Flow Characteristics: **Slow**

Infiltration: **None** Pipe Seal Cond: **Unknown**

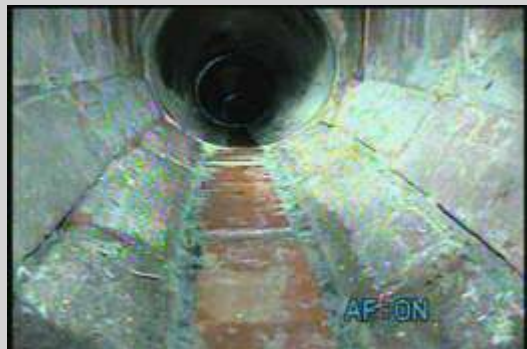
6 O'Clock Inflow

8 in. Circular Gravity Sewer
Pipe In @ 6 O'Clock

Pipe Material: **Clay** ☐ Pipe Lined

Infiltration: **None** Pipe Seal Cond: **Unknown**
